**Eagle Zinc – March 2, 2004 Site Visit  
Photograph Log**

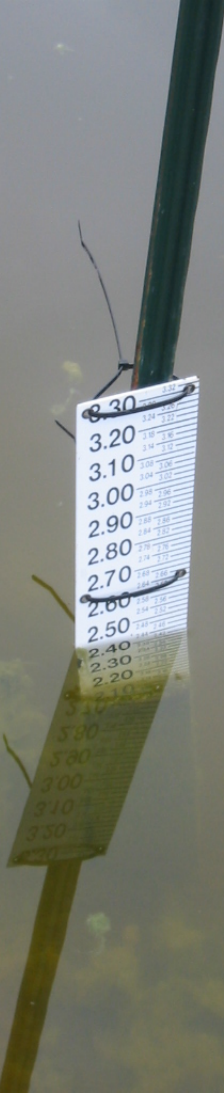
<b>Photo Number (See Map for Photo Location)</b>	<b>Description</b>
20	Woodpecker holes in tree on north side of SW pond, facing north.
21	Water level indicator near the south shore of the SW pond. The water level was approximately 2.425 feet at this location, and appeared higher than usual.
22	SW pond, standing at outfall, facing east.
23	Outfall of SW pond, facing north.
24	Outfall floor from SW pond, facing west.
25	SW pond outfall, facing east.
26	Confluence of SW pond outlet and the cement factory drainageway. Waterway had significant alga growth and reddish-brown discoloration. The area is a floodplain, and the waterway course may change frequently. On the map this confluence is offsite, but was on-site at the time of the visit.
27	Confluence of drainageways downstream of SW pond, facing east.
28	SW drainageway below confluence of SW pond outlet and cement drainageway. Waterway had a significant amount of algae and a reddish-brown color. On the map this area is off-site, but when visited, the fence that indicates the western site boundary was further downstream. The confluence and course of the waterway may change frequently, as there is significant scouring on the edges of the waterway, and the ground was saturated.
